UNITED STATES ENVIRONMENTAL PROTECTION AGENCY
REGION 5
77 WEST JACKSON BOULEVARD
CHICAGO, IL 60604

SUBJECT: INSPECTION REPORT – Gulfport Energy, Boy Scout Well Pad, Harrison County, Ohio, API: 34067210970000

Date of Inspection: July 31, 2013

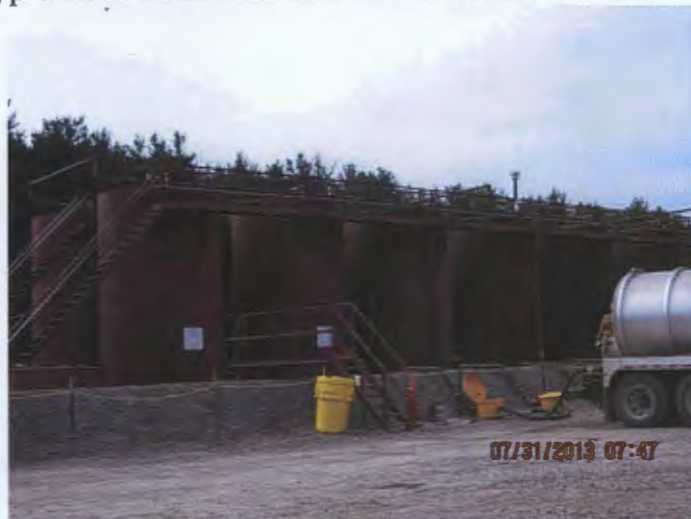
We observed four well heads and what appeared to be four process trains at the site. The site has four produced water tanks and 10 tanks identified as condensate tanks. We observed the contractors emptying produced water tanks into a truck labeled as "brine."

Photo 1: IMG_0694, produced water truck loading

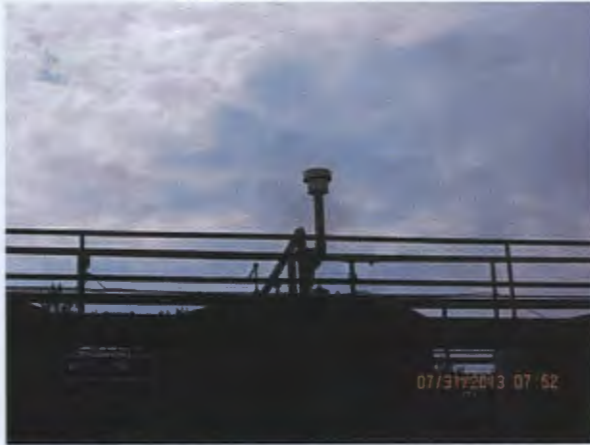
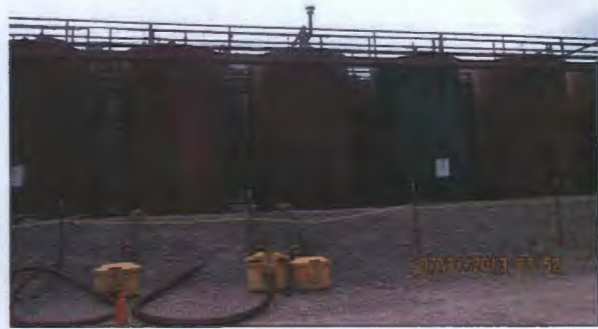
From the ground near the tanks, we observed visible refractory from the common tank header. At the base of the tanks, the PID instrument alarmed with a reading of 84 ppm and I observed a strong natural gas odor. K. Loukeris recorded a video of the hydrocarbon plume emanating from the tank header with the FLIR camera (MOV_0360). Photos 2 and 3 below are still photos of the video.

Photos 2 and 3 – IMG_0695 and IMG_0696, storage tanks, correspond to MOV_0360

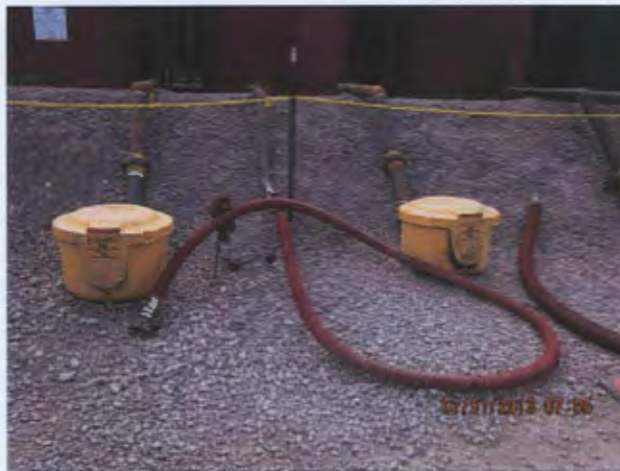
K. Loukeris continued to survey the site with the FLIR camera and observed active gas emanating from a vent hose resting on the ground outside of the tank area. The contractor stated that it should be closed and tightened the end with a wrench. K. Loukeris recorded one FLIR video of the plume (MOV_0361). Photo 4 below is a still photo of this video.

Photo 4 – IMG_0697, vent hose, corresponds to MOV_0361
